# Operations Department

## Second Quarter Report, 2019

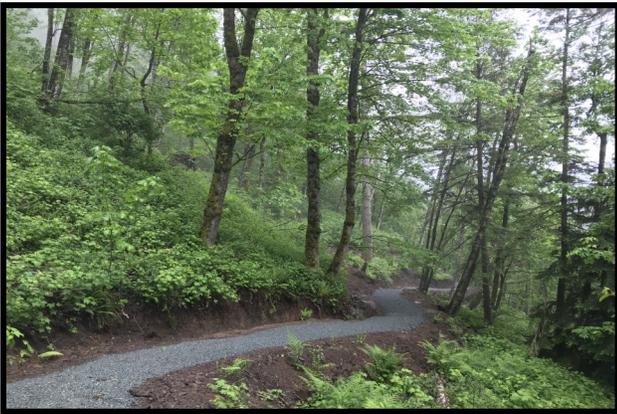
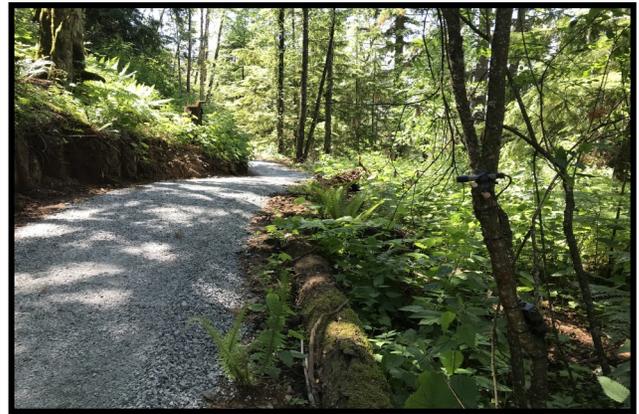
### Mt. Thom Summit Bypass Trail

A new 560m connector trail between Karver’s Trail and a lower part of Thom Creek Trail was completed to allow users to bypass some of the steeper sections of Thom Creek Trail. The work involved using a mini excavator to clear and cut in trail on a slope that exceeded 50% in places and required cuts into the hillside of up to 2m. The trail follows an easier grade throughout and will be at least 2m wide along the whole length of the trail. The new trail offers spectacular views of the valley along with a gentler grade that will attract users to Mount Thom Park who otherwise may have been put off by the steep grades found on both Karver’s Trail and Thom Creek Trail. A trail counter has been installed to gather user data to see the initial user volume. The data will be retrieved and reviewed at the end of July. Mount Thom is the second most used trail network in the City’s system with only the Vedder Rotary Trail remaining more popular.

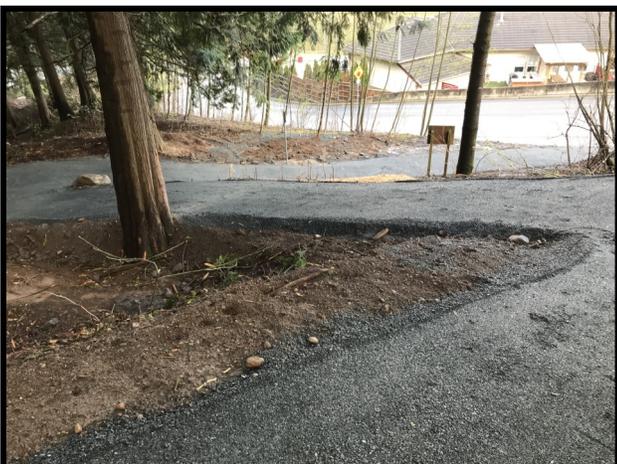
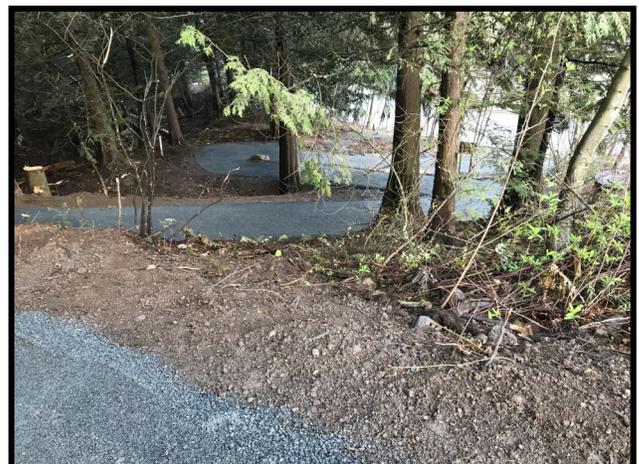
### Lower Thom Creek Stair Removal

As the stairs from the beginning portion of Thom Creek Trail at the base of Thom Creek Drive were beginning to show rot, they have been removed and replaced with a gravel 2m wide path that has been lengthened to reduce the grade. Removing the staircase has increased safety and accessibility while lowering maintenance and associated costs.

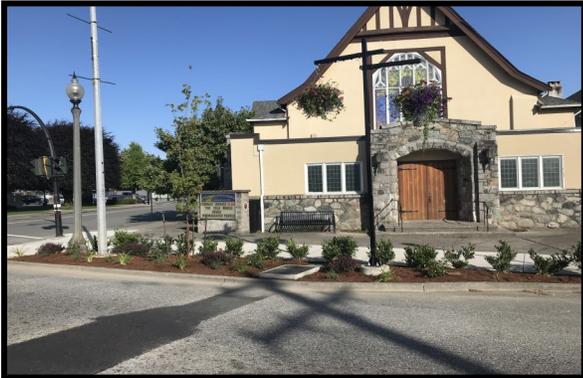
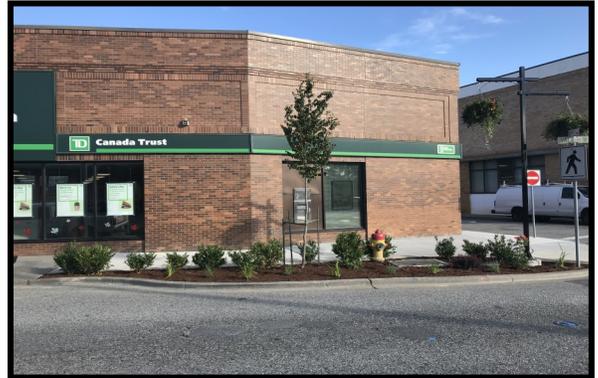
## Yale Road Downtown Greening

As part of the City of Chilliwack’s greening initiative, five garden beds along Yale Road from Spadina Avenue to Kipp Avenue were replaced. Each of the garden beds were raised high above the sidewalk and had overgrown trees that were raising the surrounding sidewalk bricks and creating dangerous tripping hazards. The gardens, trees and surrounding brick were all replaced. The brick was replaced with a new concrete sidewalk and the garden beds were lowered back down to sidewalk height. All gardens received a new planter pole, flowers, shrubbery and an ornamental tree.

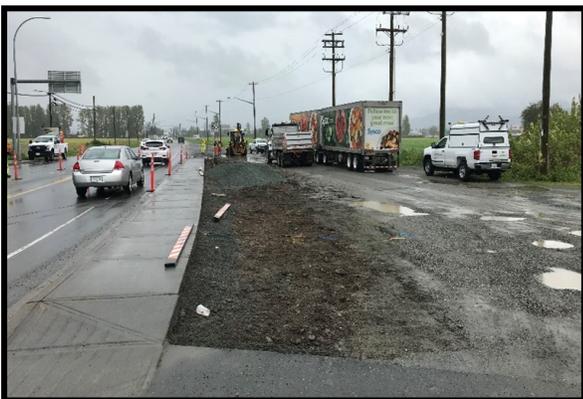
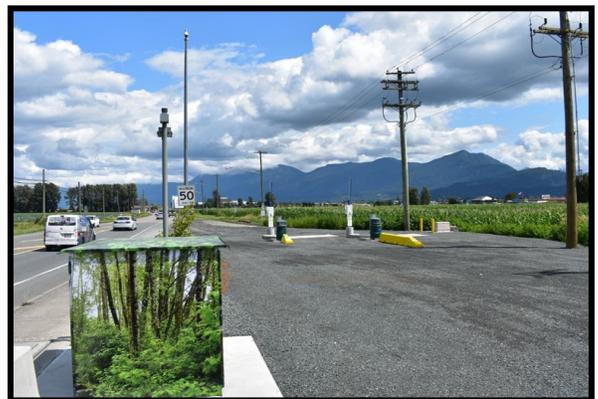
## Additional SaniDump Location Added

The SaniDump facility at Heritage Park was constructed in 2001 and since then has seen a steadily growing number of customers. By 2013, there were weekends with a queue of RVs waiting out onto Luckakuck Way, causing major traffic congestion. In 2014, works were carried out to double the size of the facility to allow two RVs to dump simultaneously. By the summer of 2016, the increased use of the facility again began to line up out onto Luckakuck Way. Staff carried out a survey to determine what other SaniDump facilities were operating in the Fraser Valley and how many of those offered free use. The majority of sites were charging a usage fee of at least \$5, so it was decided that the same should be applied to the City’s site, in order to sustain the operating and maintenance costs, as well as potential future capital costs. It was determined that it was time to give the users an alternate location to reduce the RV lineups at Heritage Park, and these collected funds were substantiated recently with the construction of an additional site at the Yale & Evans roundabout. Staff identified this location as being convenient for access with minimal disruption to neighbouring properties and existing traffic patterns. The site was constructed in the spring with the intention of being available for the summer camping season. As well as providing this alternate location, it was also determined that it was time to increase the dumping fee to \$7. Following these changes, staff have already seen a good distribution of usage between the two sites and a 63% overall increase in revenue.

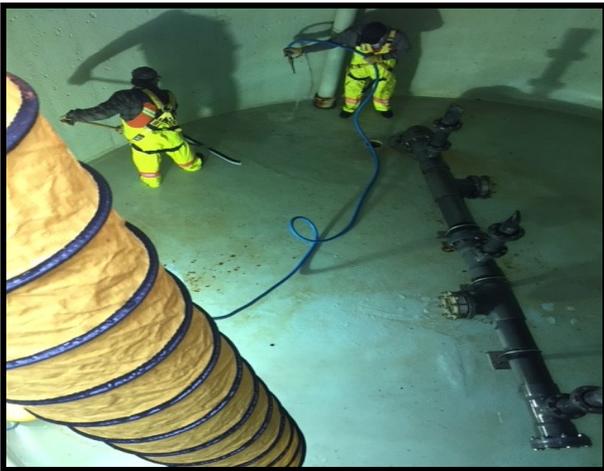
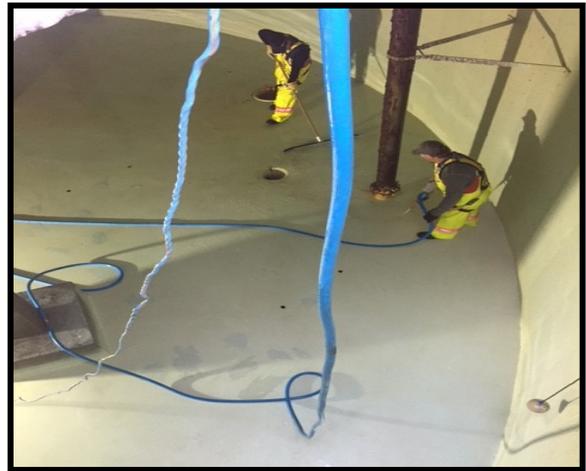
## Annual Reservoir Cleaning

The City's water distribution system includes 18 strategically located reservoirs in the hillside areas of Mount Shannon, Chilliwack Mountain, Promontory & Marble Hill. Reservoir tank capacities range from 250,000 litres to a massive 19,000,000 litre tank on Mount Shannon. The tanks are constructed out of either concrete or steel and over a span of several years the tanks see a buildup of sediment that dissipates over time from the water in the tank and settles onto tank walls and floors. Each reservoir tank in the system is drained, cleaned and refilled once every three years on a rotational cycle. Tank cleaning not only helps to maintain high water quality, the process also allows the structural components of the tank to be inspected for cracks or other defects once the tank is empty and staff can safely enter. Each of the City's reservoir tanks is equipped with various styles of mixing systems which are designed to agitate or mix the water to prevent stagnation of water and to promote lower water temperatures. This spring Operations Department staff completed the cleaning of all reservoirs in the Promontory area: four tanks in total. The tanks were found to contain very little sediment and no structural issues were noted. The tanks were refilled and returned to service for another three years.
